RE: Occupational Safety and Health Assessment, Building 334
Biosystems and Ag Engineering,

This report is an occupational safety and health and assessment of building 334, Biosystems and Ag Engineering, on the St. Paul campus.

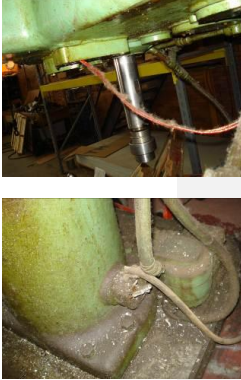
1.	Electrical Safety	Large milling machine in machinery bay has damaged and exposed electrical wiring.	Replace/repair electric wiring by qualified electrical staff

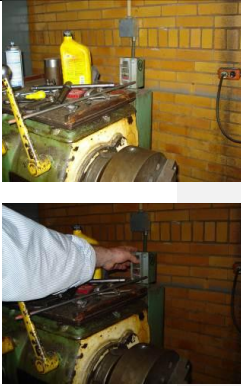
7.	Entanglement hazard	Metal machining shop. Stop/start switch is located behind lathe on the wall. Operator must reach over the machine to operate switch.	Immediately remove lathe from service, until start/stop switch is relocated to front of machine.

Provide a safety plan for woodworking and metalworking equipment including training materials and records of training to DEHS for review. Restrict access to the machines until the safety plan has been reviewed. Remove from service the metal shop lathe and milling machine until the start/stop control switches are relocated, by qualified electrical staff, to positions where the operators can safely reach them while in position at the point of operation.

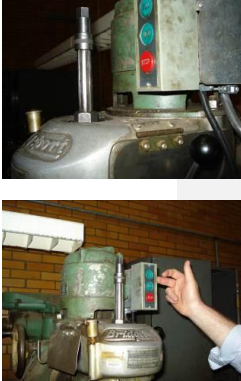
15.	Machine Guarding	Exposed drive shaft near stop/start switch on mill in machine shop is in close proximity to stop/start switch posing an entanglement hazard.	Immediately remove from service until stop/start switch is relocated away from shaft.
